Manhole Inspection Summary

Manhole # S47U1_006MH

Insp Date: **10/26/08 3:23 PM**

Location Address: **3001 Childs St.**

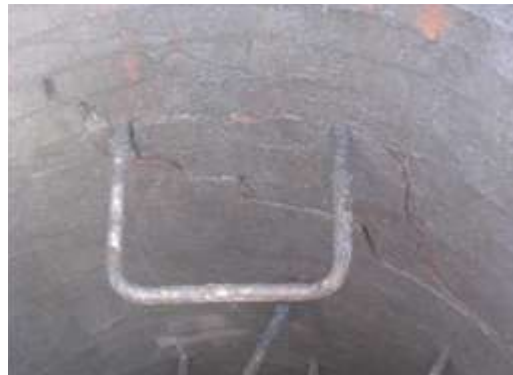
Defect 1

Condition: ☐ Sound ☒ **Cracked** ☐ Root Intrusion ☐ Loose Brick ☐ Deteriorated

Infiltration: ☐ None ☒ **Joint** ☒ **Cracks** ☐ Mortar ☐ Roots ☐ Wall

Cracked Corbel

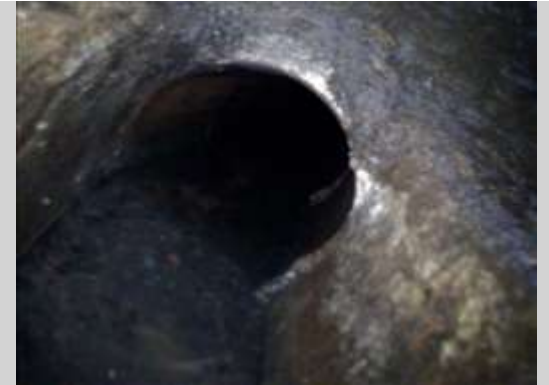
12 O'Clock Outflow

8 in. Circular Gravity Sewer
Pipe Out @ 12 O'Clock

Pipe Height: **8.4** (in.) Rod and Bar (Angled)
Pipe Material: **DIP/CI** ☐ Pipe Lined
Invert Depth: **13.90** (ft.) Flow Characteristics: **Slow**
Deposits: ☒ None ☐ **Mud** ☐ Sludge ☐ Debris ☐ **Grease**
Silt Depth: (in.) Deposits Extent:
Infiltration: **None** Pipe Seal Cond: **Sound**

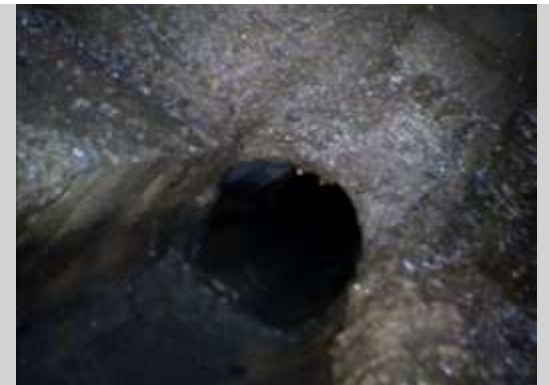
6 O'Clock Inflow

8 in. Circular Gravity Sewer
Pipe In @ 6 O'Clock

Pipe Height: **8.4** (in.) Rod and Bar (Angled)
Pipe Material: **DIP/CI** ☐ Pipe Lined
Invert Depth: **13.80** (ft.) Flow Characteristics: **Slow**
Deposits: ☐ None ☒ **Mud** ☐ Sludge ☐ Debris ☒ **Grease**
Silt Depth: **0.5** (in.) Deposits Extent: **Light**
Infiltration: **None** Pipe Seal Cond: **Unknown**
